DIESEL TO DETRITUS (A)

DIESEL TO DETRITUS

Part B

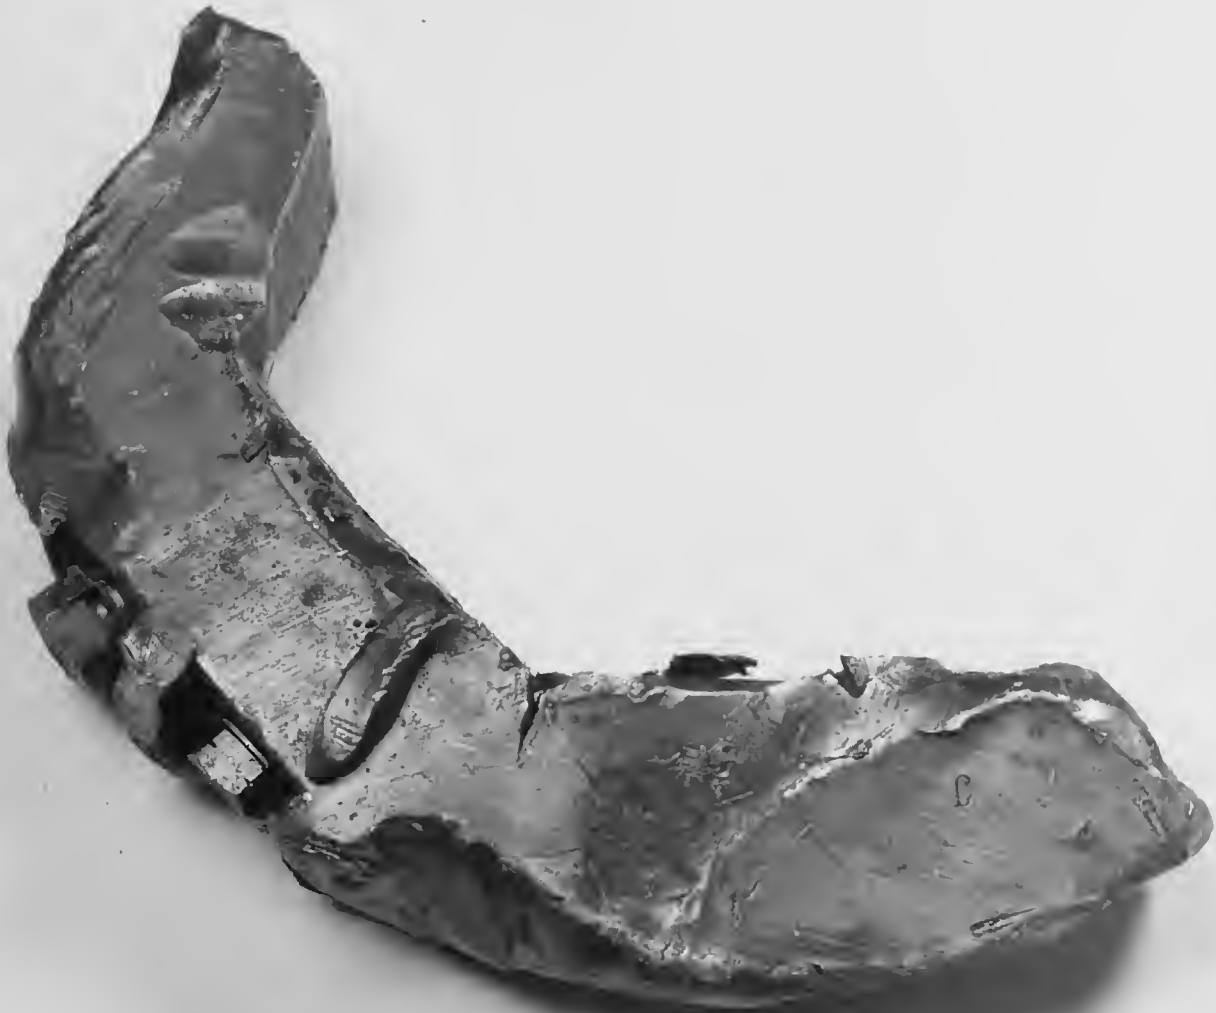
The counterweight, after removal from the engine, is shown in Figure 1. This counterweight was lodged between the connecting rod and the cylinder block.

Fig. 1: Counterweight showing gouges and generally damaged condition after removal from the engine. Approx. $\frac{1}{2}X$

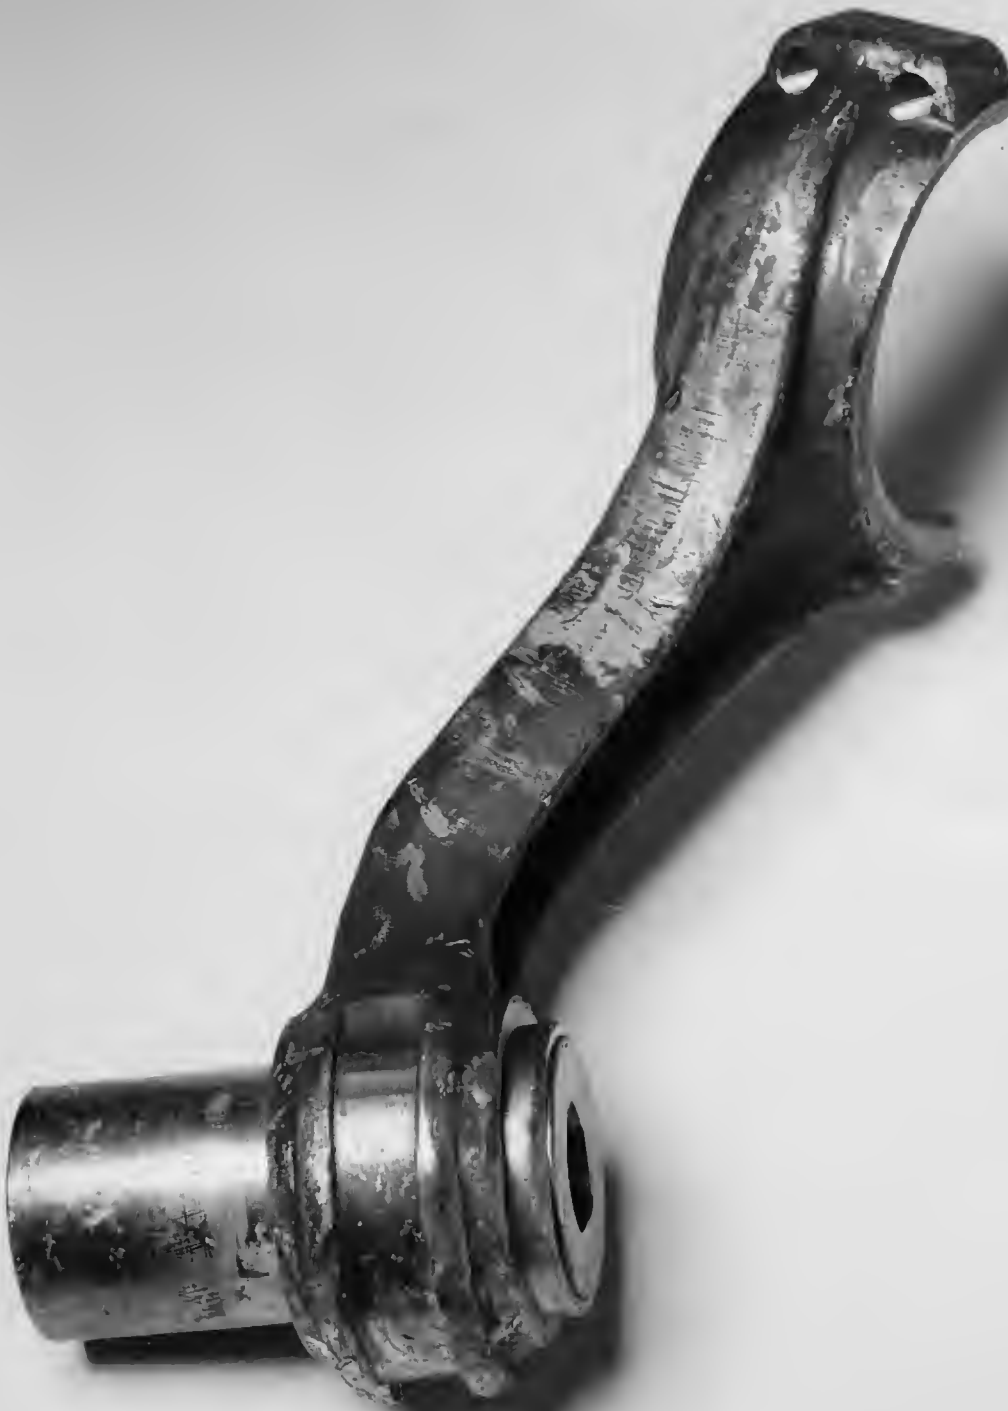
The connecting rod from No. 6 cylinder is in Figure 2. A definite bend is obvious in the originally straight rod, forged in an H section from alloy steel.

Fig. 2: Connecting rod and wrist pin from No. 6 cylinder. Note the appreciable bend.
Approx. $\frac{1}{2}X$

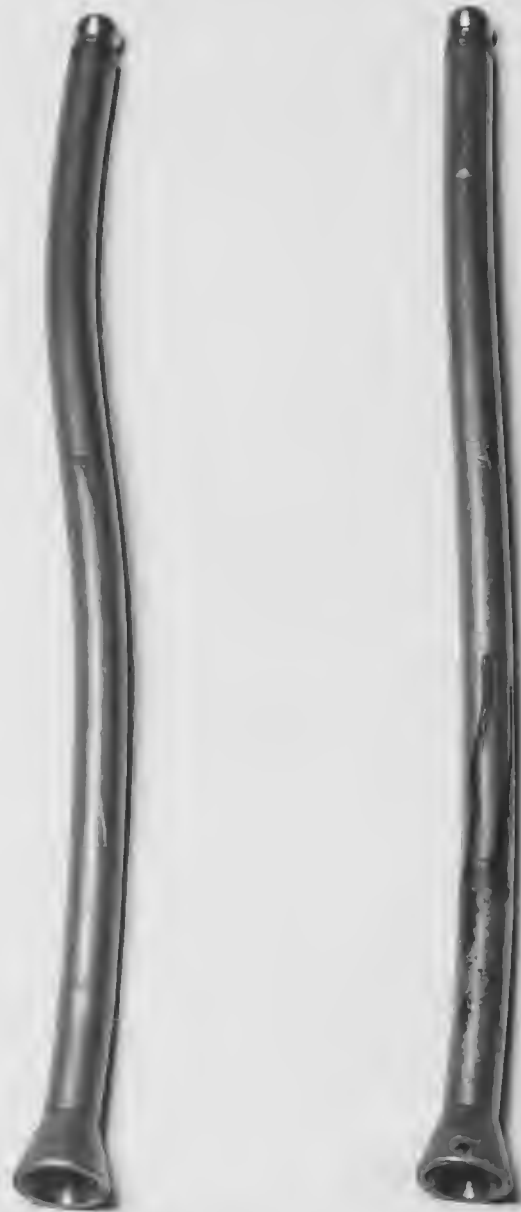
The push rods from No. 6 cylinder are seen in Figure 3. Both rods are obviously bent with one more so than the other.

Fig. 3: Push rods from No. 6 cylinder. Approx. $\frac{1}{2}X$

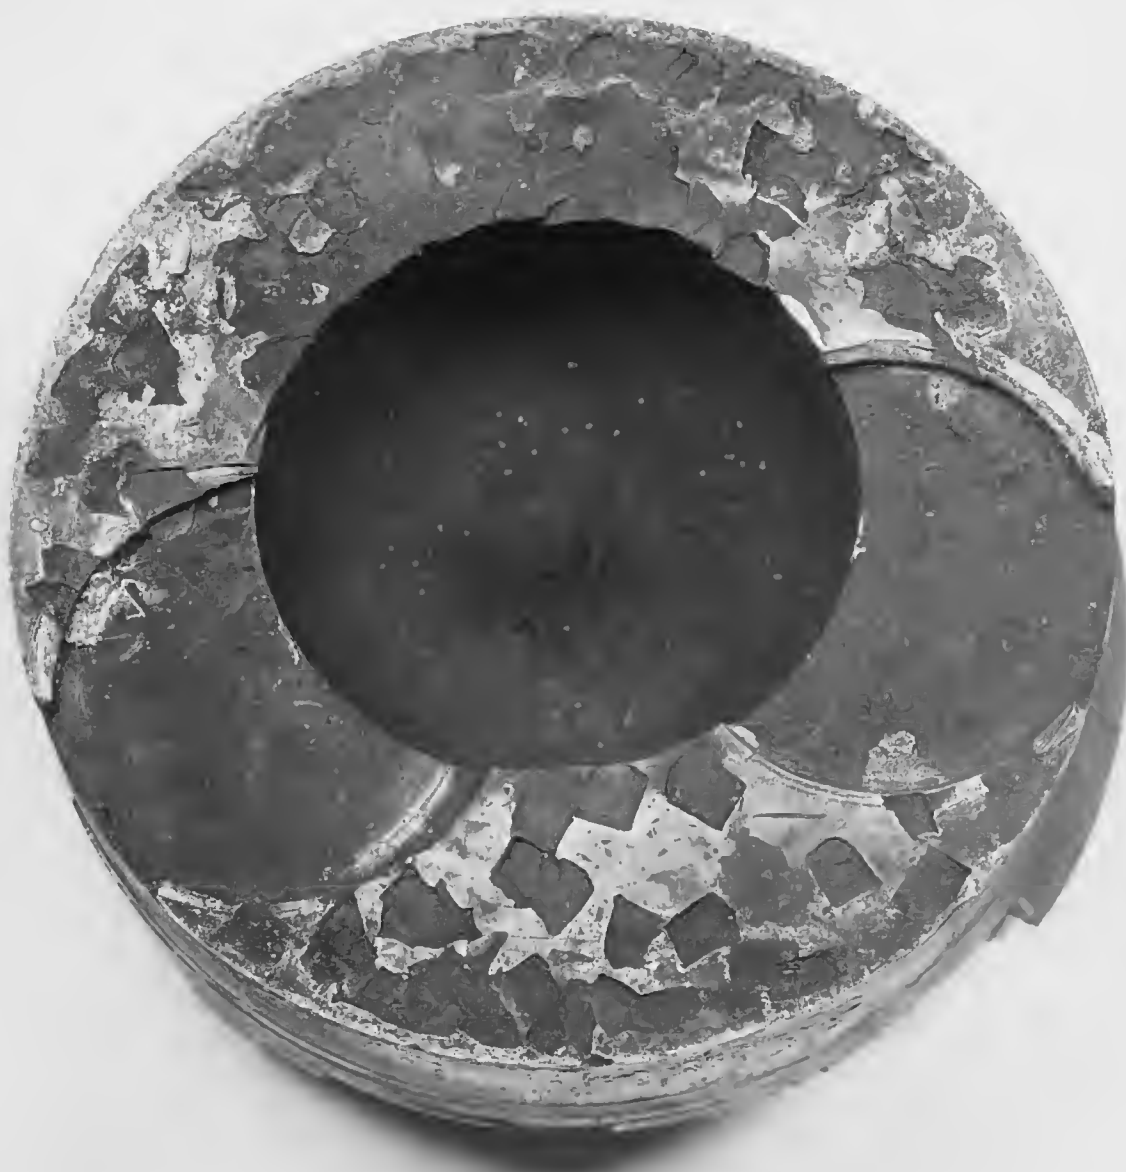
The top of the piston from No. 6 cylinder is seen in Figure 5. The "square" dark markings on the top are actually indentations in the piston which was made of a low expansion aluminum alloy. The supports on the underside of the piston for the wrist pin were broken off. There was also a crack across the bottom of the piston.

Fig. 5: Top of piston from No. 6 cylinder. The "square" dark areas are actually indentations in the aluminum piston. Approx. 1X

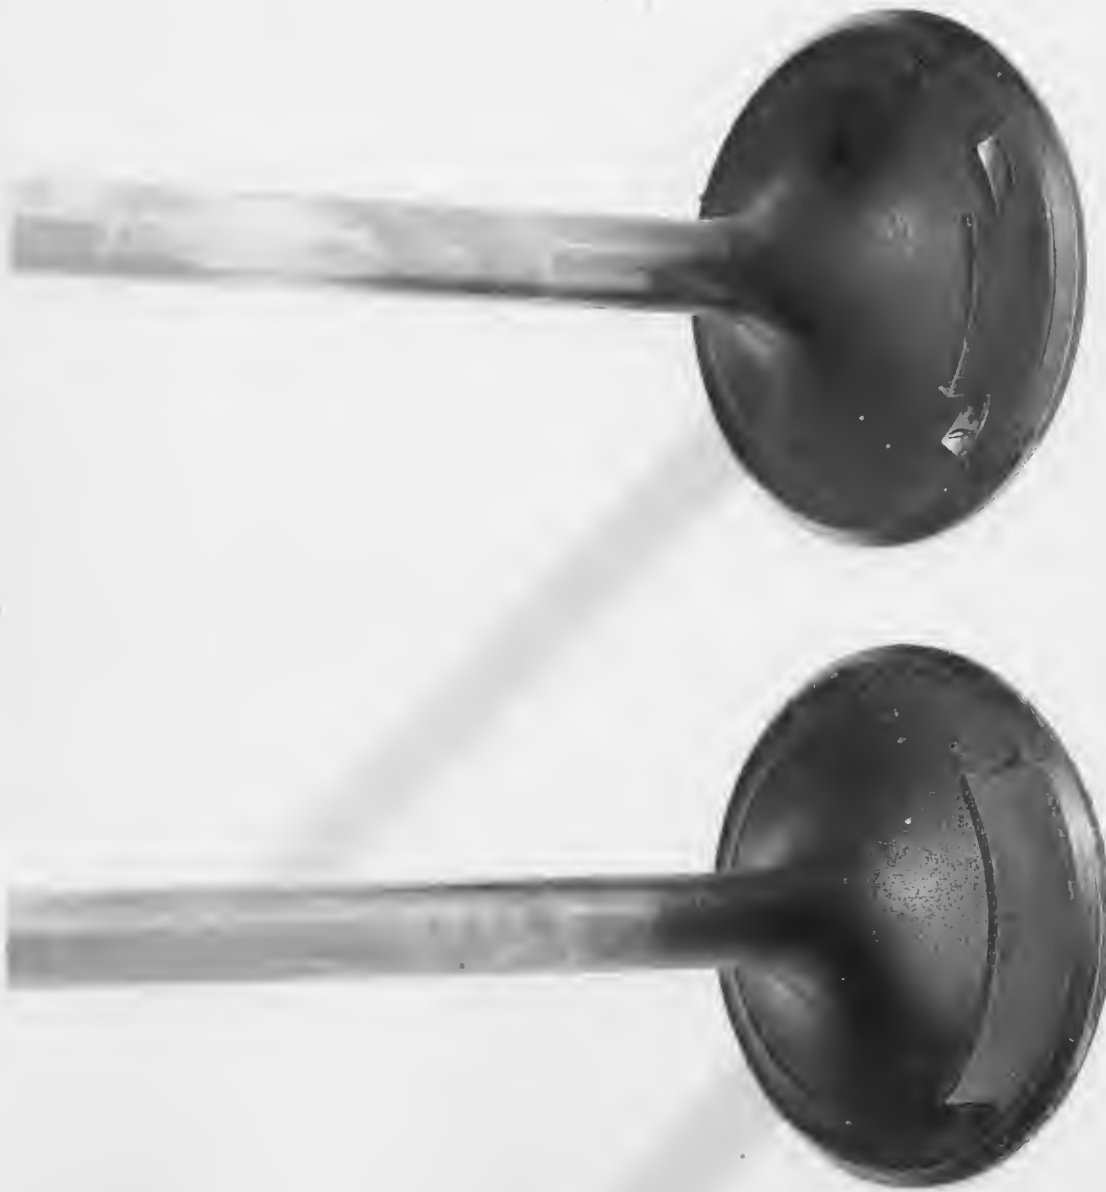
Two inlet valves are shown in Figure 6. The one on the left is from No. 5 cylinder and shows no evidence of damage. The valve on the right is from No. 6 cylinder. It is obvious that two segments are missing from the deflector. Definite chevron markings were obvious to the eye.

Fig. 6: Inlet valves -- from No. 5 cylinder on the left, from No. 6 cylinder on the right. Note two sections are missing from the deflector on the valve from No. 6 cylinder. Approx. 1X

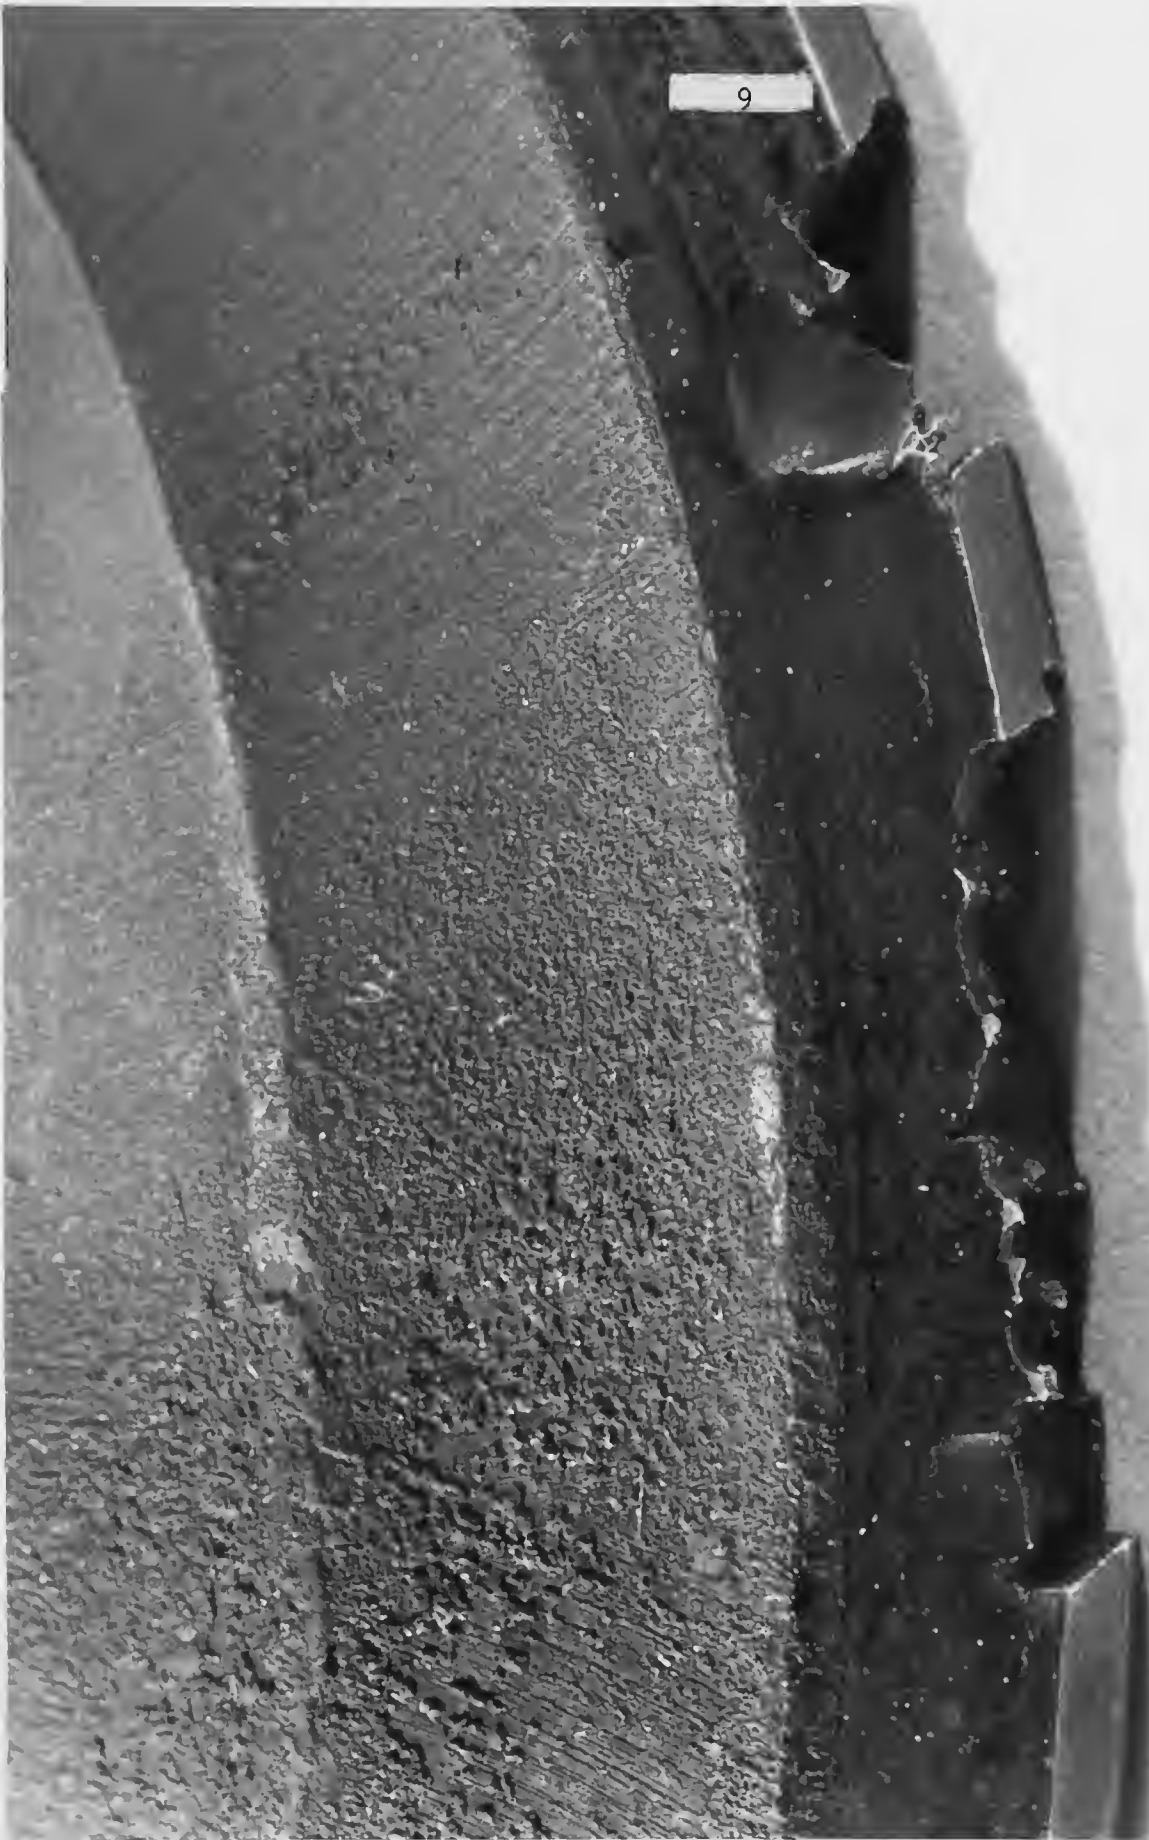
The top surface of No. 6 inlet valve diametrically opposite the deflector is seen in Figure 7. In addition to the portions missing from the edge, there are two small indentations. Some portions are missing along the edge in the same location on the bottom side of the valve.

Fig. 7: Top side of inlet valve from No. 6 cylinder located diametrically opposite from the deflector. Approx. 10X

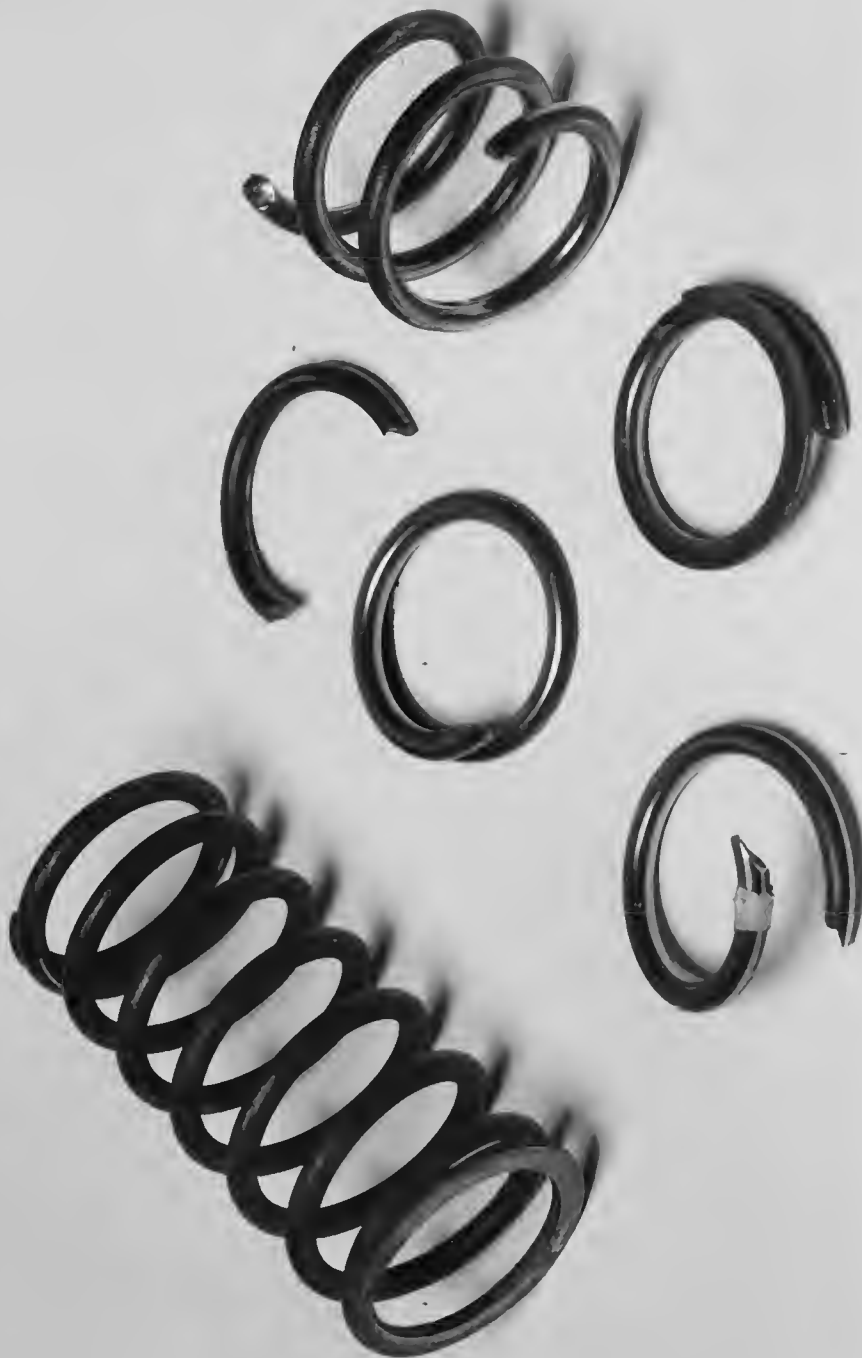
Figure 8 shows the outer spring from No. 5 cylinder with five segments of the outer spring from No. 6 cylinder. It is not certain that these were the only segments from this spring. The fracture ends of each of these five segments were carefully examined under a binocular microscope.

Fig. 8: Outer springs from inlet valves -- The complete spring is from No. 5 cylinder. The five segments shown are from No. 6 cylinder. Approx. $\frac{3}{4}$ X

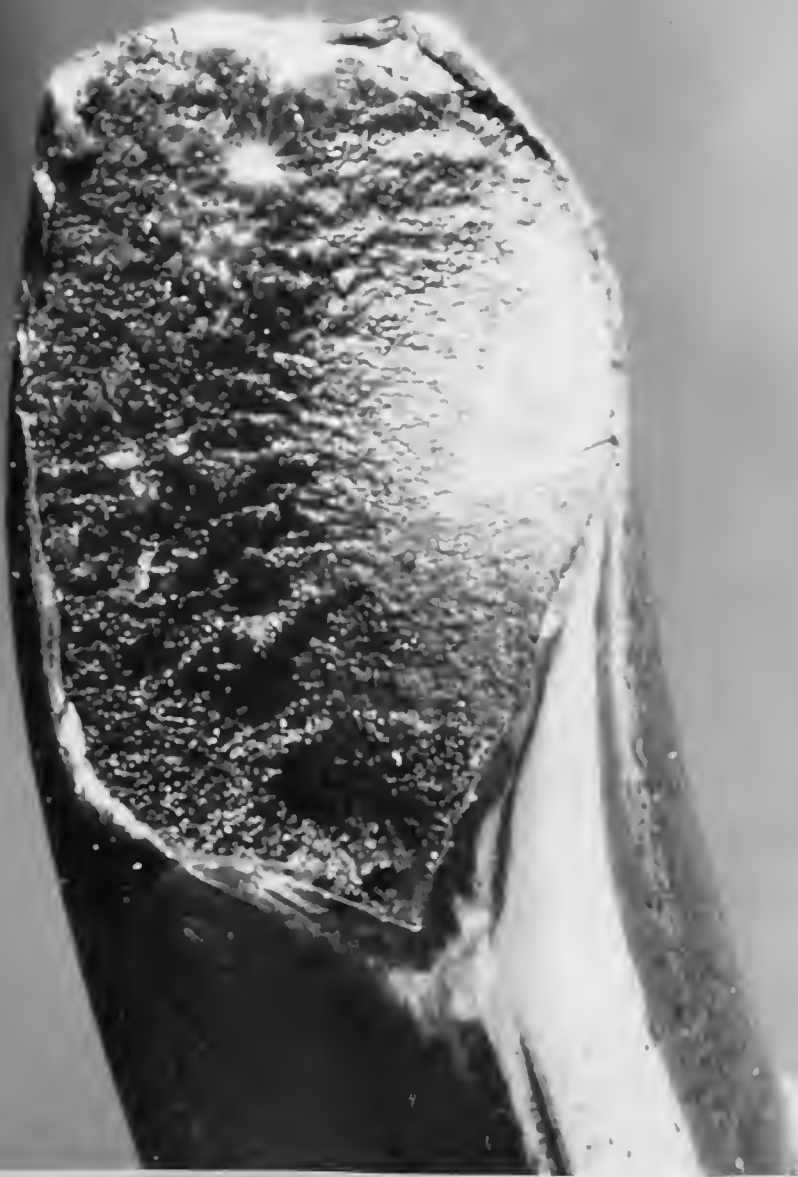
Figures 9 and 10 show the fracture surface of one segment of No. 6 outer spring, the one indicated by the piece of tape around a segment in Fig. 8.

Fig. 9: Fracture surface of one segment of the outer spring from No. 6 cylinder, taken approximately perpendicular to the fracture surface. (See segment marked by tape in Fig. 8) Approx. 15X

The fracture surface of the spring (Figs. 9 & 10) is typical of a fatigue failure. The bright region in the fracture surface (Fig. 9) is relatively smooth and failed first. The typical "beach marks" of fatigue were not as well developed (or obvious) as one might like (and often sees). No doubt, electron microscopy would have made the fatigue striations clear. The bright region in Fig. 9 is the "smooth" region at the front of the fracture surface in Fig. 10.

The rough surface (pitted or pockmarked) of the spring segment shown in Figs. 9 & 10 provides ample points of stress concentration to initiate fatigue failure. Operation of the spring clearly provided cyclic stressing in the spring. It might be noted that failure started on the inside radius of the spring where the tensile stresses are much higher than on the outside radius of the spring. It might also be noted that the surface of the spring from No. 5 cylinder (Fig. 8) is slightly rough, presumably from shot peening, which is performed to introduce residual compressive stresses on the surface to develop longer service life. It is obvious that the "roughness" from shot peening is not the same as the pitting surface imperfection seen in Fig. 10.

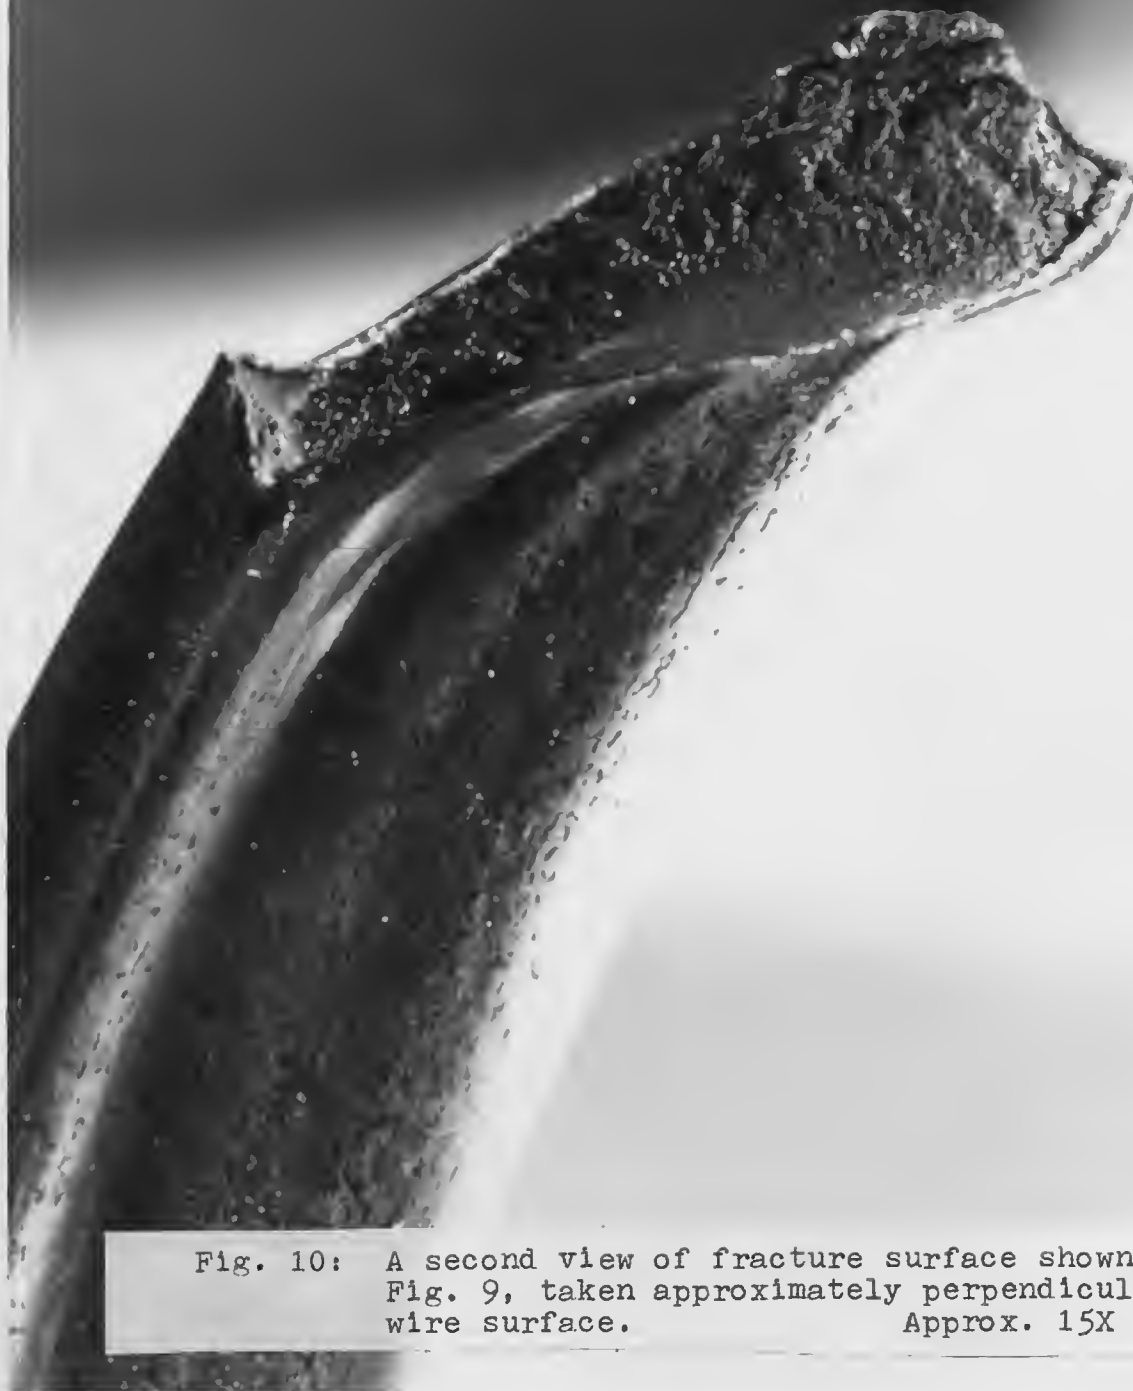
Fig. 10: A second view of fracture surface shown in Fig. 9, taken approximately perpendicular to wire surface. Approx. 15X
